U.S. Department  
of Transportation  
**Federal Aviation  
Administration**

# **General Aviation Airworthiness Alerts**

**AC No. 43-16**

**ALERT NO. 232  
NOVEMBER 1997**

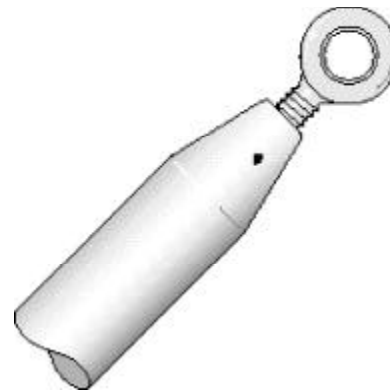
While complying with the requirements of Airworthiness Directive (AD) 97-06-11, the left ruddervator push-pull rod (P/N 35-524106-6) was found to contain water.

AD 97-06-11 requires removal of the paint from the push-pull rod to facilitate dye-penetrant inspection. When the paint was removed, a hole, which was approximately .25 inch in diameter, was found at the lower

forward end of the rod. (Refer to the following illustration.) Corrosion originated in the interior of the rod and progressed through the wall thickness. This area is not visible during normal inspections. The paint coating was still covering the damaged area. Rain water and other contaminants may seep past the rod-end threads or find other entry points to the interior of various flight control push-pull rods. During a period of time, moisture may collect and cause corrosion damage. Any evidence of interior moisture in a control rod should be thoroughly investigated.

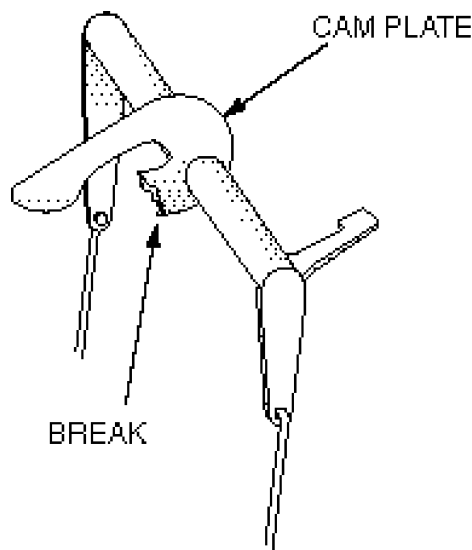
**Nose Landing Gear  
Door Failure  
5280**

An inspection revealed the lower portion of the cam-plate slot on the shaft (P/N 002-410038-1), which is used to close the nose gear doors, had broken. (Refer to the following illustration.) The fracture area had been polished smooth by the cam pin which would indicate that this defect had been present during several previous flights. These parts are located in an area which is easily accessible for inspection. The submitter suggested these parts be given close attention during inspections and maintenance. Beech Service Bulletin (SB) 2601 addresses this subject; however, SB 2601 is not applicable to Model 58 aircraft. It was suggested that the manufacturer consider either revising SB 2061 to include Model 58 aircraft or issue a separate SB for Model 58 aircraft.

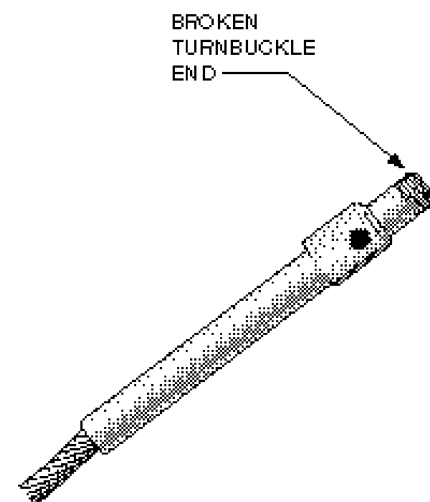
During a scheduled inspection, the main landing gear downlock cable was found broken.

An investigation disclosed that the downlock cable (P/N 60-810089-5) terminal end had broken at the threads used for adjustment and attachment to the clevis terminal (P/N AN665-10R). (Refer to the following illustration.) The terminal end safety wire had been routed through the clevis fork and was still holding the broken cable terminal to the clevis terminal. The safety wire kept the retraction system operational; however, it may have failed at any time. The threaded terminal end broke where it entered the clevis threads. The submitter stated the broken cable terminal end displayed evidence of being bent, possibly more than once, at the failure point. A "boot" covers the assembly and protects it from contamination. The "boot" must be removed before this area can be inspected.

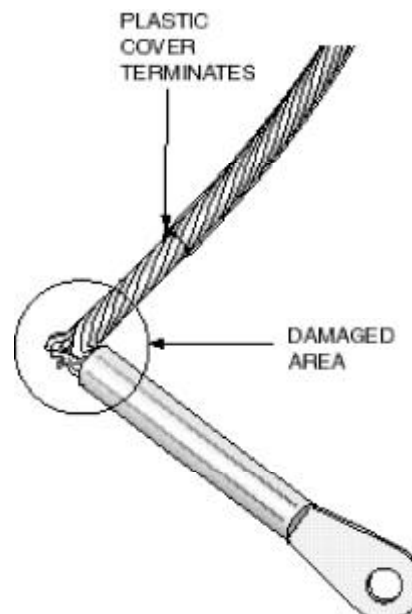
During a scheduled inspection, the left main landing gear emergency release cable was found severely damaged.

The cable (P/N 128-380021-29) was kinked. There were numerous broken strands where the cable entered the terminal at the uplock release end, and the cable was close to complete separation. (Refer to the following illustration.) If the cable had separated, the left main gear would not have extended. The submitter stated finding two other like aircraft with broken landing gear emergency release cables, and all of the failures were similar. The cable is covered with plastic, which is terminated approximately 1 inch from the terminal end, to allow for proper swaging of the fitting. The cables typically fail between the end of the plastic covering and the swaged terminal fitting.

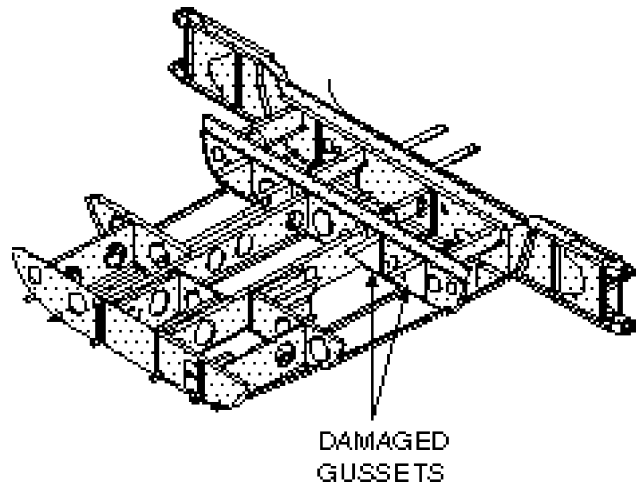
During a scheduled inspection, cracks were found in the pilot's seat supporting structure.

The cracks were found in two gussets (P/N's 5011011-7 and -10). The gussets were located below the cockpit floor. Each gusset was cracked just beneath the floor line at the top of the gussets. (Refer to the following illustration.) The submitter recommended the manufacturer authorize the installation of doublers on these gussets or construct them from more substantial material. This defect was reported for two like aircraft of the submitter's fleet. Although no cause for this type defect was given, age and metal fatigue may have been contributing factors.

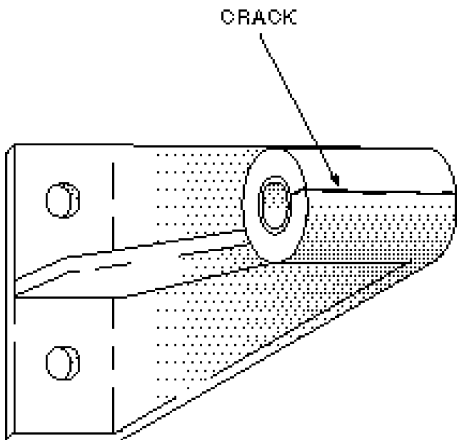
While the inspection requirements of Airworthiness Directive (AD) 63-26-03 were being complied with, the elevator hinge was found damaged.

The left outboard elevator hinge bracket was found cracked across the attachment lobe. (Refer to the following illustration.) This hinge bracket is not a part of AD 63-26-03. The cracked hinge bracket was found when the elevator torque tube was removed, and the elevator was hanging in a vertical position. In-flight failure of the hinge bracket could result in a catastrophic accident.

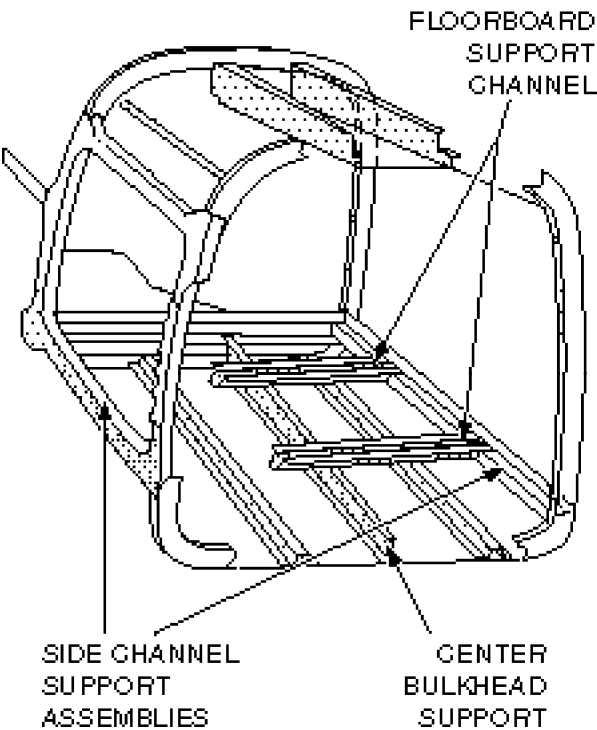
During a scheduled inspection, the rear baggage compartment floor was found to have severe structural damage.

This aircraft was used strictly for carrying cargo. It appeared the damage was the result of extreme abuse while loading and unloading cargo. Both of the floorboard support channels (P/N's 32057-02 and -03) were broken from their attachment to the left and right side channel support assemblies (P/N 32038-00). The center bulkhead support (P/N 32047-00) was crushed and distorted. (Refer to the following illustration.) This damage severely compromised the structural integrity of the airframe, and an in-flight separation could have occurred.
